46TH TURBOMACHINERY & 33RD PUMP SYMPOSIA
HOUSTON, TEXAS | DECEMBER 11-14, 2017
GEORGE R. BROWN CONVENTION CENTER

Challenges with a large high pressure water injection pump

ABSTRACT

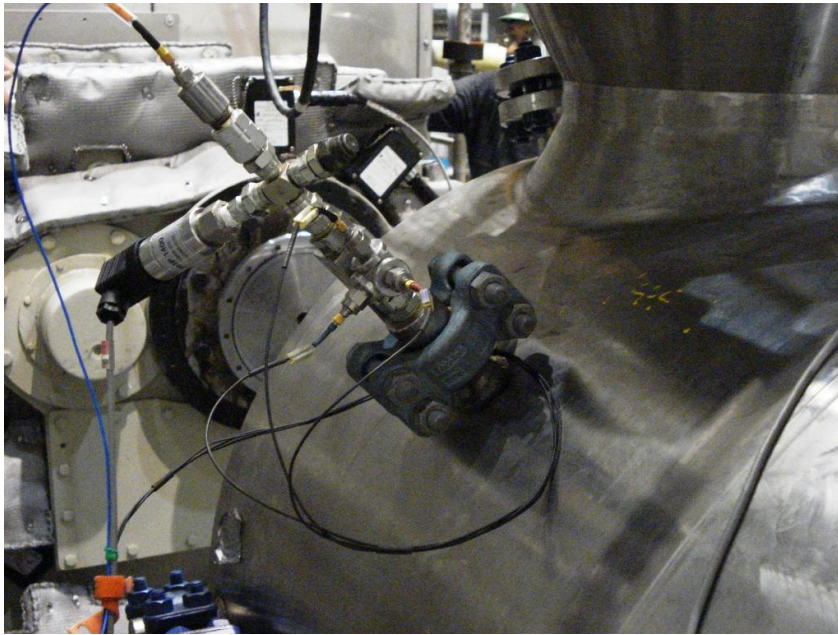
Figure 7. Dynamic pressure transducer on 1st stage impeller discharge tap during string test(Sulzer)

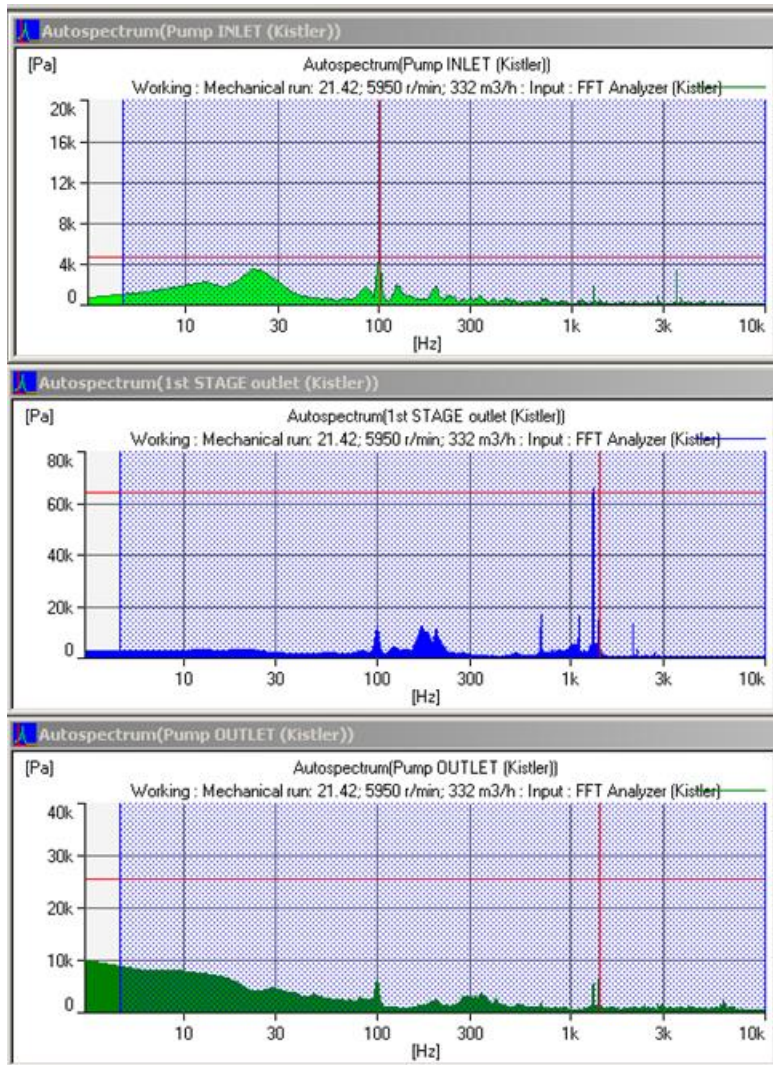
Figures 6 and 7 show pictures of the overall string test set-up as well as the instrumentation used to measure the dynamic pressure during the full-load string test. The dynamic pressure was recorded at three different locations (suction, 1st stage outlet, and discharge) during the test. The results of the testing are shown in Table 4 and Figure 8 below. As expected, the pulsation is a strong function of speed and proximity to minimum flow. The overall pulsation levels were relatively low, with a maximum dynamic pressure recording of 1.66 bar (24 psi) at maximum speed and minimum flow. Additionally, a spectrum of one of the dynamic pressure points is shown in Figure 9. Of concern is the peak on the 1st stage impeller discharge spectrum at approximately 1400 hz. This is relatively close to the 2-Diameter mode shown in Table 3. Likewise, because all of the impellers have 7 vanes, this is relatively close to the 2nd harmonic of vane pass frequency ($6000 \text{ rpm} / 60 \times 7 \text{ vanes} \times 2 = 1400 \text{ hz}$).

Figure 9. Spectrum of pressure pulsation at inlet (top), 1st stage outlet (middle), and pump outlet (lower) (Sulzer) 10000 Pa = 0.1 Bar = 1.45 psi

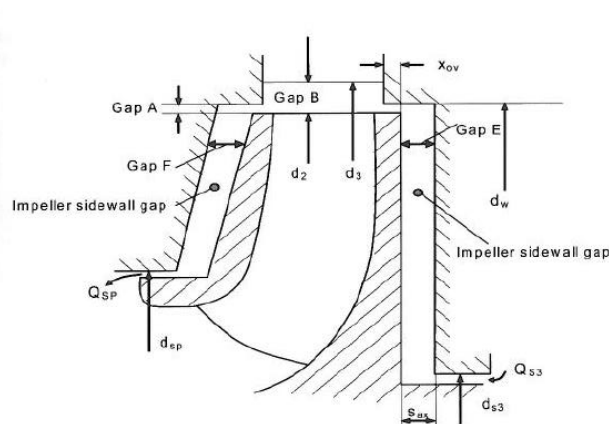
While the pulsation levels didn't appear to be high, there was concern over the pulsation peak that was close to the 2-D impeller mode. The Industry experience has shown that increasing the clearance between the impeller vane outside diameter and the diffuser vane inside diameter (commonly called the B gap) decreases the pulsation levels. Figure 10 is an illustration showing the basic pump impeller geometry at the outlet. Equation 1 from Gulich [1] roughly indicates the relationship between pulsation generated from high energy centrifugal pumps and the B gap. This equation shows that if the B gap is doubled, the pulsation is reduced by approximately 40% with the downside of losing efficiency due to increased volumetric losses. For the subject pump, if the impeller/diffuser gap ratio was doubled from 3.5 to 7.0% the OEM calculated impeller fatigue design factor increases to 1.54. However, the 7% B gap resulted in too large reduction in the produced head for the water injection system. According to the OEM and based on the previously stated impeller fatigue analyses, a B gap of 5.7% was required to meet the latest internal design criteria of 1.3. This should improve the impellers reliability because the pulsation energy is predicted to be reduced by approximately 30%.

Figure 10. Centrifugal pump impeller/diffuser cross-section showing impeller/diffuser gap ratio (d_3/d_2), commonly called "B" gap

An additional spare cartridge was purchased with 285 mm impellers, instead of the original 288 mm (this increased the B-gap from 3.5 to 5.7%). Performance tests showed that this reduced the measured pulsation over most of the flow range, see Figure 11, but it also reduced the produced head by approximately 8% which is more than the affinity laws predicted $(285/288)^2=0.979$, see Figure 12. To meet injection demands the maximum speed of the power turbine was increased from 9060 to 9453 rpm, resulting in a pump speed of 5940 to 6200 RPM for the 285 mm pump cartridge only. This was possible because the original design limited the gas turbine's power turbine speed to 95 % of Max Continuous Operating Speed.

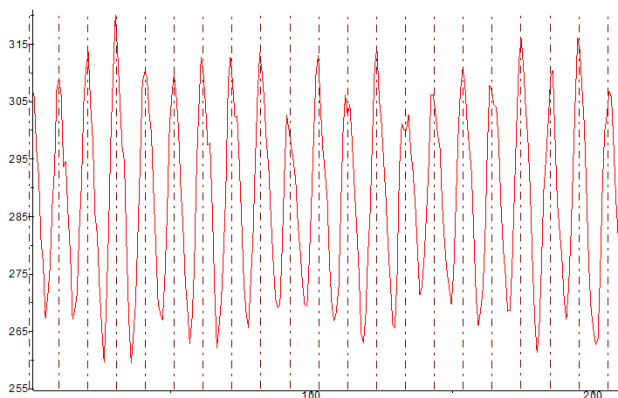
After the shaft failure, the spare cartridge with 285 mm impellers was installed in the B pump casing. The pump operated normally for several months until operations personnel noticed an unusual noise and vibration when the B pump was in operation. A predictive maintenance technician was called to investigate the noise and discovered a unique situation. The pressure pulsation in the equalizing chamber / balance line was very high: appx 41-48 bard (600-700 psid), see Figure 21. The bushing/sleeve in Figure 14, reduces the pressure on the outboard end of the pump from approximately 276 to 19 bar (4000 to 280 psig). Because the pressure pulsation seemed unreasonably high, the pulsation was recorded in the same location on the A pump, see Figure 22. This confirmed that the pressure recording was correct. Because of the previous issue with the broken shaft, it was decided to pull the B pump cartridge and tear down the pump.

Figure 22. Dynamic pressure pulsation (psi) recorded on A pump balance line during operation (appx 265 to 315 psi)

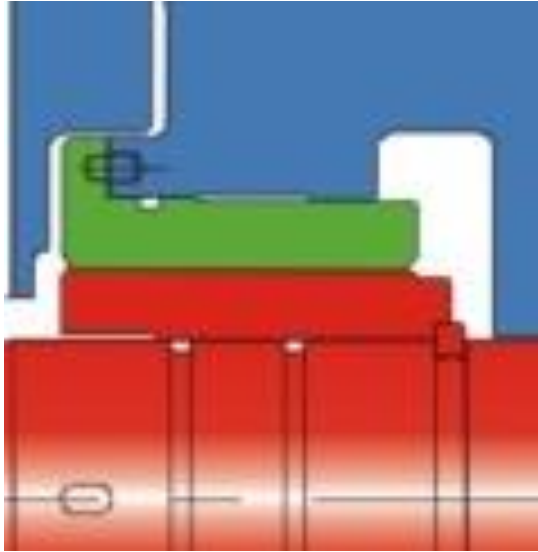
Inspection of the pump didn't reveal a broken shaft as was found previously; however, the problem was found in the same location. Figure 23 is an enlarged view of the outboard bushing/sleeve shown in Figure 14 above. The sleeve has a relatively low interference fit to the shaft of appx 25 to 50 μm (0.001-0.002 in) and requires a pair of O-rings between it and the shaft to seal the almost 276 bard (4000 psid) of differential pressure. A shrink fit with higher interference to eliminate the need for o-rings was not selected by the OEM because this would have increased the sleeve thickness. The would have had increased shaft stresses since the sleeve acts like a piston with differential pressure. Because of the high differential, a set of split rings with a keeper ring secures the sleeve to the shaft axially. Inspection of

the pump found that the inboard O-ring (left hand side of Figure 23) under the sleeve had been cut, probably during installation, see Figure 24. The split rings and the axial groove in the shaft showed evidence of fretting, see Figures 25 and 26. This indicates that the rings were being loaded axially in a cyclic manner. The failure of the inboard O-ring allowed high pressure water to migrate a significant length under the sleeve. This may have caused the sleeve to “bow” or “flap” on the shaft, causing the pressure pulsation in the balance chamber. The pump OEM used an FEA model to simulate the effect of the failed O-ring on the sleeve, see Figure 27. As a solution, the throttle sleeve design was modified again to reduce the possibility of damaging the O-ring on installation by increasing the chamfer on the inlet side in alignment with newer designs of the same pump type which were introduced in the meantime. Installation of the spare cartridge in the B pump lowered the pulsation to approximately 7 bard (200 psid), see Figure 28, but still higher than the A pump which had only 3.2 bard (50 psid). Both pumps have operated for the past 3 years with no more reliability issues. The pulsation on the balance chamber is still routinely recorded and has not increased.

Figure 23. Detail of throttle bushing (green) and sleeve (red) on shaft (Sulzer)

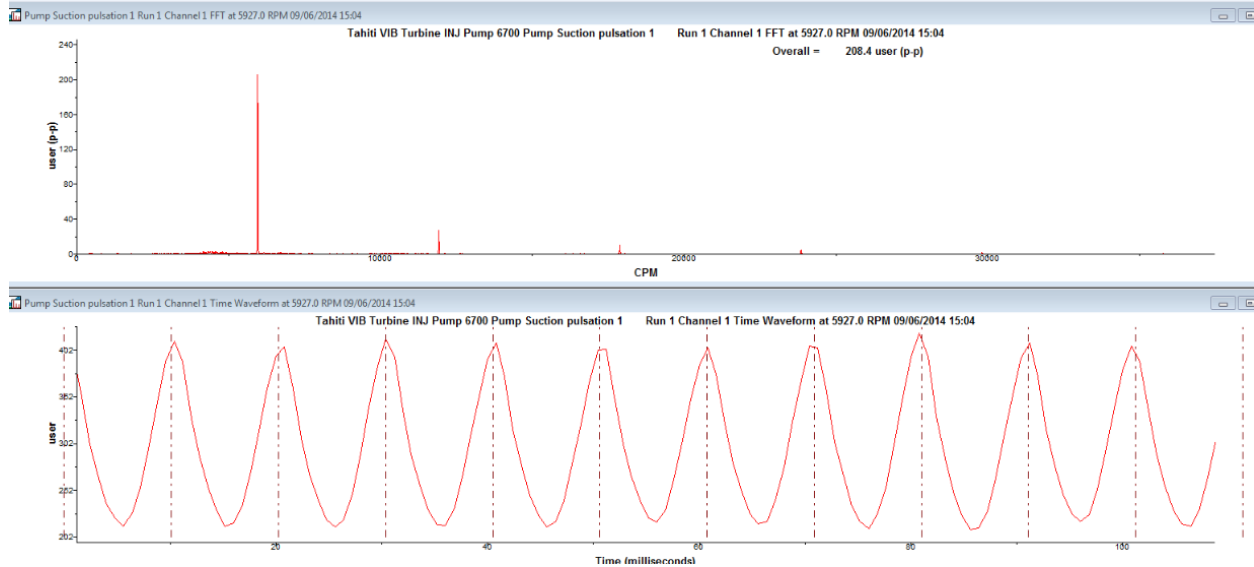
Figure 28. Measured dynamic pulsation (psi) on B pump after replacement cartridge was re-installed appx 14 bard (185 psid), from measured pressure in range of 15 to 28 bar (220 to 405 psi)
